# CAF® CASE STUDY

## Egg Processing

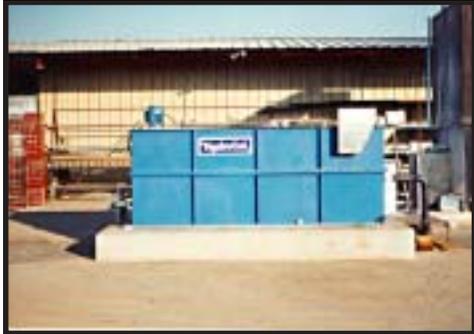
CAF unit installed at an egg ranch/plant.

Hydrocal's scheduled a trial, which immediately demonstrated that the CAF unit would achieve results well within the new regulations and a unit was installed.

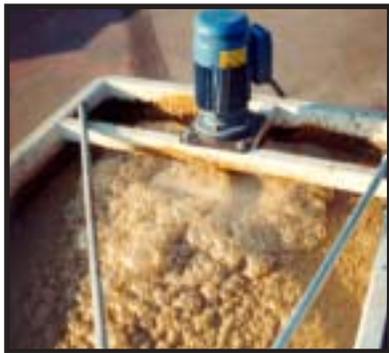
A thick layer of solids floating on the surface prior to discharge.

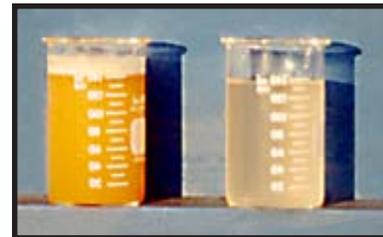
Before After

Clear Effluent

<u>Influent</u>	<u>Effluent</u>
Gallons per day	30,000	27,800
pH Adjustment	11.0	7.0
Suspended Solids	2,200 ppm	20 ppm
