# CAF® CASE STUDY

## Olive Processing

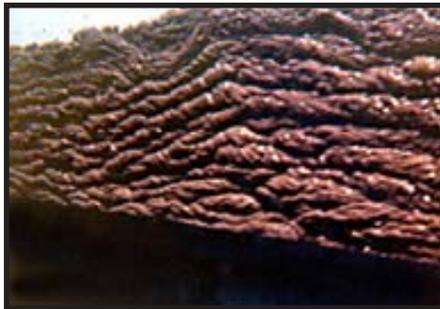
*Removal of fats, oils and greases, and suspended solids*

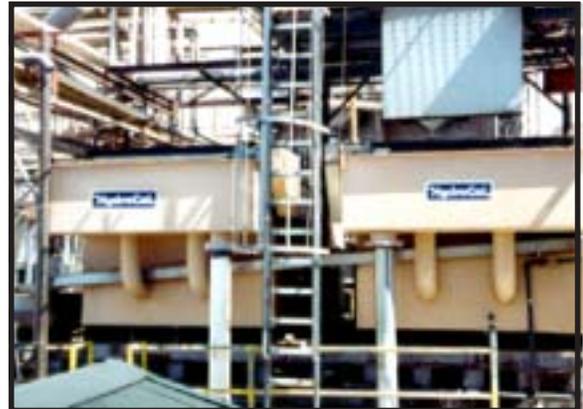
*Twin CAF systems installed in an olive plant.*

A Hydrocal CAF system is installed to treat the pit water only. This stream, which aligns the olives to be pitted, is highly contaminated with oil, grease, and ruptured olive tissue. The separate treatment of this stream alleviates the treatment of the final discharge and the pit water effluent can be recycled to convey the olives.

Then we installed a CAF system on the final stream going to the sewer plant or to the oxidation ponds. The system removed most of the colloidal matter, oil, grease and suspended solids. The effluent discharged is an amber clear solution.
