CAF[®] CASE STUDY

Automotive Paint

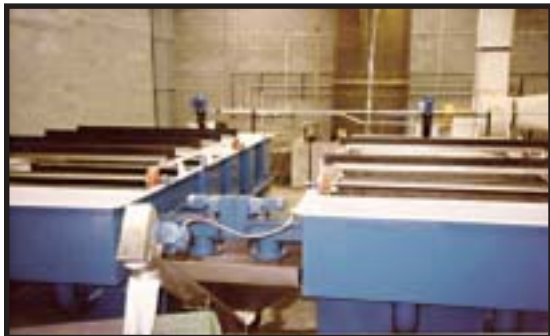
The two CAF-75 units operating side by side.

Hydrocal installed a CAF system, which proved very effective and simple in removing paint sludge from the shower curtain water.

The three units were so successful in cleaning the paint booth recycled process water that within twelve hours automatic timers were installed. The units now run on automatic cycle intermittently 24 hours a day.

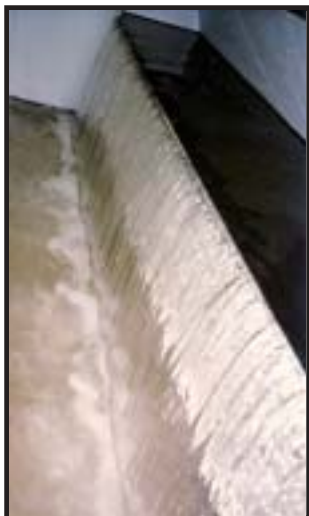
Clarified effluent.

Total Suspended Solids Results

Influent	500-1000 ppm
Effluent	10-15 ppm
% Removal	98.5 %
